Manhole Inspection Summary

Manhole # S13C__014MH

Insp Date: **1/21/09 10:04 AM**

Location Address: **REAR OF 617 FRANKLINTOWN RD** Cross Street: **EDMONSON AVE**

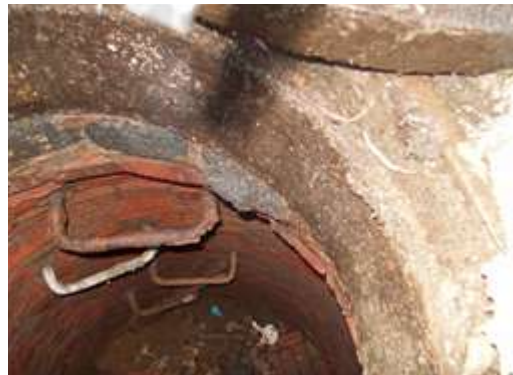
Defect 1

Steps Count: **4** Missing: **0** ☒ **Corroded**

Surcharge ☒ **Evidence Of Surcharge** Depth: **1** (ft.) ☐ Active Surcharge Present

CORRODED STEP; EVIDENCE
SURCHARGE

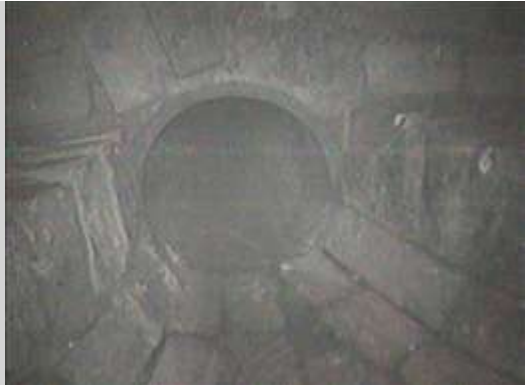
12 O'Clock Outflow

8 in. Circular Gravity Sewer
Pipe Out @ 12 O'Clock

Pipe Material: **Clay** ☐ Pipe Lined

Invert Depth: **8.33** (ft.) Flow Characteristics: **Slow**

Deposits: ☒ None ☐ Mud ☐ Sludge ☐ Debris ☐ Grease

Infiltration: **None** Pipe Seal Cond: **Sound**

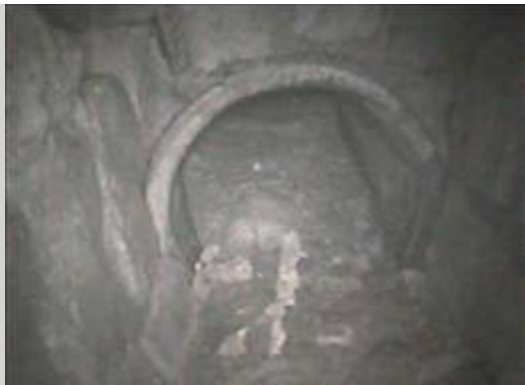
5 O'Clock Inflow

8 in. Circular Gravity Sewer
Pipe In @ 5 O'Clock

Invert Depth: **8.04** (ft.) Flow Characteristics: **None**

Deposits: ☐ None ☒ **Mud** ☐ Sludge ☒ **Debris** ☐ Grease

Silt Depth: **1** (in.) Deposits Extent: **Light**

Connects To: **House connection / Service line**

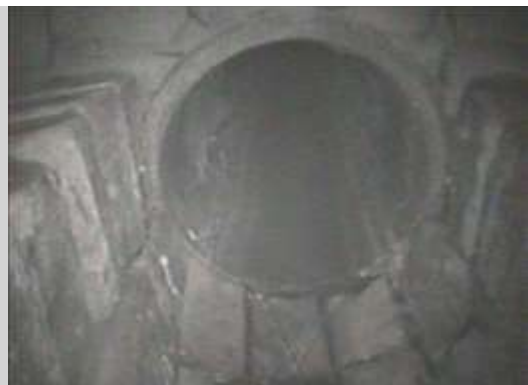
9 O'Clock Inflow

8 in. Circular Gravity Sewer

Pipe In @ 9 O'Clock

Invert Depth: **8.10** (ft.) Flow Characteristics: **Slow**

Deposits: ☒ None ☐ Mud ☐ Sludge ☐ Debris ☐ Grease

Infiltration: **None** Pipe Seal Cond: **Sound**
